Metallosis following a clip breakage in a total knee arthroplasty implant: A case report

Ahmed Isam Saad, Shafiq Arif Shahban, Richard Fernandes

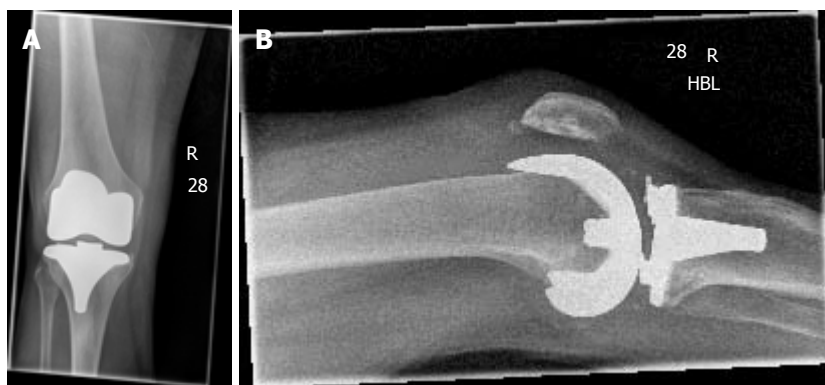
Her initial blood investigations revealed significantly raised inflammatory markers with a white cell count (WCC) of $20.27 \times 10^9/L$, neutrophils of $16.68 \times 10^9/L$ and C - reactive protein (CRP) of 186 mg/L, suggesting an acute infection. Radiographs of the knee showed a relatively well positioned in-situ TKR, with no evidence of loosening, with the possibility of a joint effusion (Figure 1A and B).

Figure 1 Initial radiographs of the right knee. A: Anterior-posterior radiograph of the right knee; B: Lateral radiograph of the right knee.

With regards to the pre-operative radiographic images (Figures 1A and B) it was not immediately recognised that the clip had broken and moved out of position. In retrospect, there is a suspicion that the broken metal clip is visible in the initial set of radiographs. Whether or not pre-operative recognition would have aided in planning is debatable, as the decision to debride the joint was made on clinical grounds of a possible diagnosis of septic

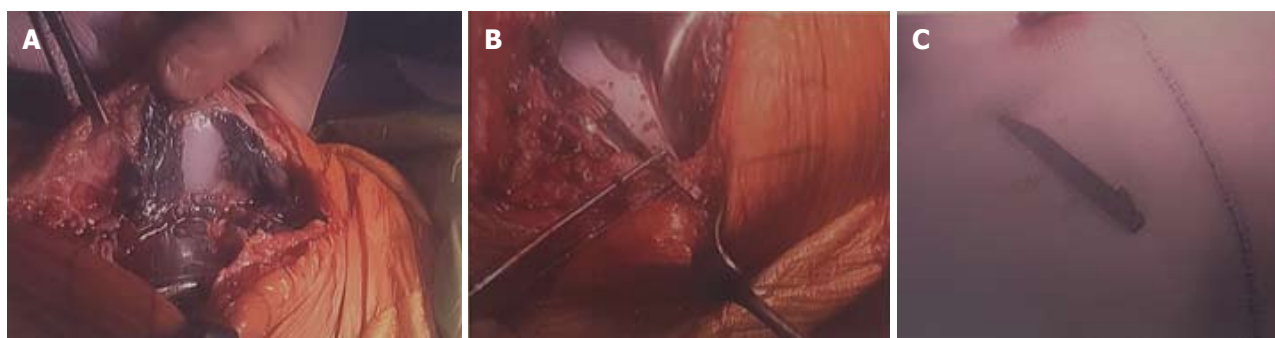
After the initial arthrotomy was made, significant purulent, dark coloured fluid extruded from the joint. The knee joint was formally opened and at this point no pus was seen, however there was a significant amount of metallosis debris deeply embedded into the soft tissues surrounding the knee prostheses (Figure 2A). On further inspection, it was clear that the metal clip which is normally used to secure the polyethylene insert to the tibial base plate had broken and dislodged (Figures 2B and C). Despite this broken metal clip, the polyethylene liner was still in its original position, and on further examination the femoral, tibial and patella implants were all well fixed with no evidence of loosening. There was also no evidence of significant macroscopic wear of the femoral and tibial components.

The broken metal clip was retrieved successfully and in whole (part being dislodged and part being well fixed in the polyethylene liner). The Vanguard® TKR system is no longer used in our trust, and consequently we were unable to replace the liner and metal clip. This lady therefore went on to have a thorough soft tissue debridement of her metallosis and lavage with copious normal saline solution. She later had a second staged procedure (after a total of 18 d) at which point we were able to obtain the correct implants, and thus provide her with a new polyethylene liner and metal clip to secure it in place. In the interim, between stages, she was prescribed a course of two grams of intravenous flucloxacillin antibiotics (to complete a six week course) and was restricted with her weight bearing, to prevent polyethylene liner displacement.

Superficial and deep tissue samples from the time of her 1st procedure did not grow any organisms. The histology report demonstrated areas of black necrosis with reactive fibrosis, a giant cell foreign body reaction triggered by black, irregular metallic particles, confirming the diagnosis of metallosis.

Figure 2 Intraoperative images of the soft tissues surrounding the *in-situ* total knee replacement. A: Intraoperative Image of extensive soft tissue metallosis; B, C: The retrieved broken metal clip.

Different companies have different ways in which one can secure the polyethylene liner to the tibial base plate. In the case of the Vanguard® TKR system, one is required to slide the metal clip through both the liner and tibial component, thus allowing for a secure hold of the two. Clip breakage is not a recognised complication of TKR, and very rarely occurs. One would expect that when the clip breaks, this disrupts the position of the polyethylene component, which would ultimately lead to displacement or even dislocation of the knee joint. In our case, though we found the insert to be stable, we concluded that the broken and loose part of metal clip was abrading the metal back components of the joint, and thus triggering the metallosis inflammatory reaction.
